Manhole Inspection Summary

Manhole # S43E__053MH

Insp Date: **5/7/09 12:21 PM**

Location Address: **1514 S DALLAS ST**

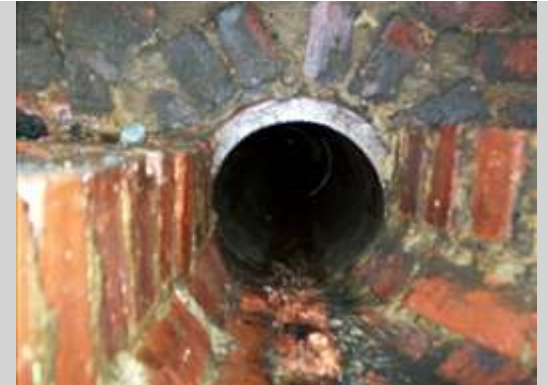
12 O'Clock Outflow

8 in. Circular Gravity Sewer
Pipe Out @ 12 O'Clock

Pipe Height: **8.4** (in.) Rod and Bar (Angled)
Pipe Material: **Clay** ☐ Pipe Lined
Invert Depth: **10.70** (ft.) Flow Characteristics: **Slow**
Deposits: ☒ None ☐ Mud ☐ Sludge ☐ Debris ☐ Grease
Silt Depth: **0** (in.) Deposits Extent:
Infiltration: **None** Pipe Seal Cond: **Sound**

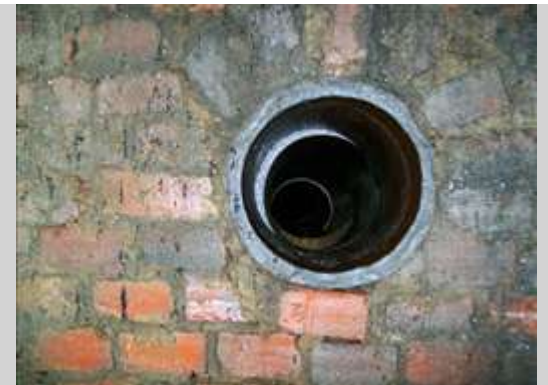
3 O'Clock Inflow

8 in. Circular Gravity Sewer
Pipe In @ 3 O'Clock

Pipe Height: **8.4** (in.) Rod and Bar (Angled)
Pipe Material: **Clay** ☐ Pipe Lined
Invert Depth: **8.79** (ft.) Flow Characteristics: **Slow**
Deposits: ☒ None ☐ Mud ☐ Sludge ☐ Debris ☐ Grease
Silt Depth: **0** (in.) Deposits Extent:
Infiltration: **None** Pipe Seal Cond: **Sound**

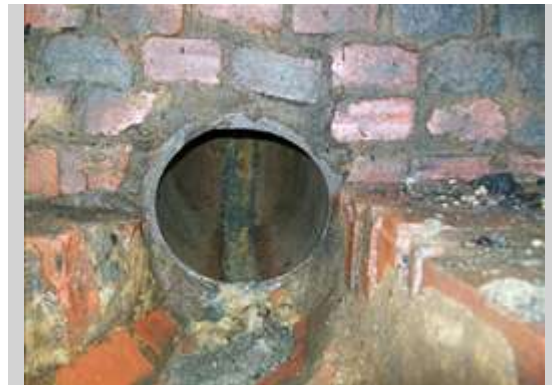
Drop In @ 3 O'Clock

Drop: **Outside** Rod and Bar
Angled: **Yes** Reading: **9.65** (ft.)
Inv Depth: **10.65** (ft.)
Drop Condition: **Open**

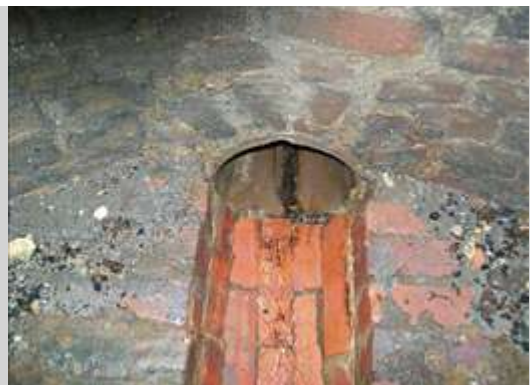
6 O'Clock Inflow

8 in. Circular Gravity Sewer
Pipe In @ 6 O'Clock

Pipe Height: **8.4** (in.) Rod and Bar (Angled)

Pipe Material: **Clay** ☐ Pipe Lined

Invert Depth: **10.59** (ft.) Flow Characteristics: **Slow**

Infiltration: **None** Pipe Seal Cond: **Sound**
